**2009 Annual Inspection Report**

**LITTLE LAKE SHORELINE  
PROTECTION / DEDICATED  
DREDGING NEAR ROUND LAKE  
(BA-37)**

State Project Number BA-37  
Priority Project List 11

July 2009  
Terrebonne Parish

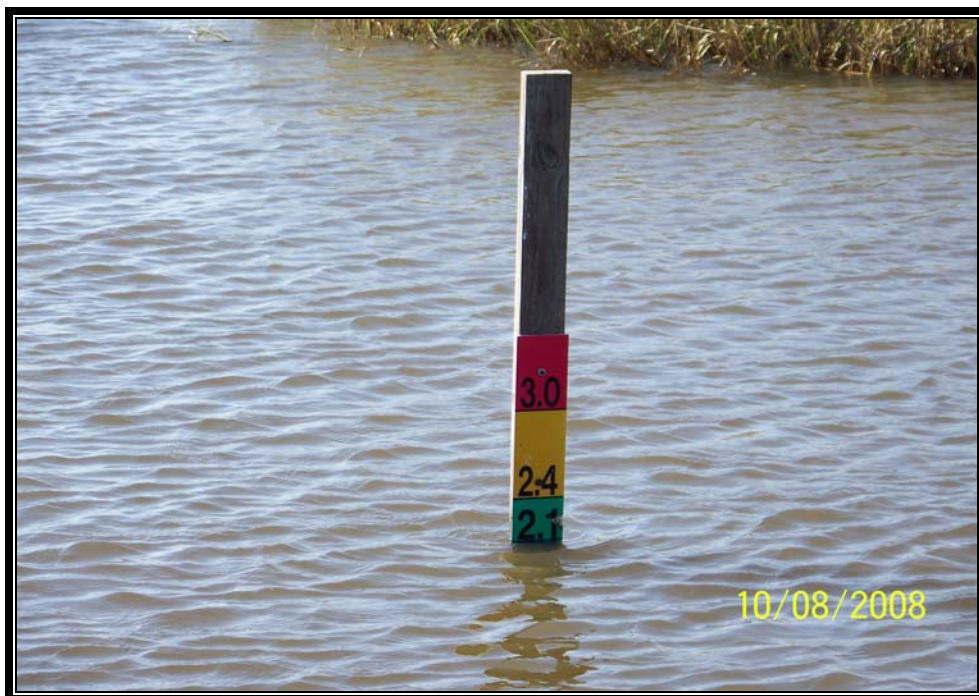
Photo 30 (0707) - Grade stake at southwest corner of marsh creation area within containment borrow channel.

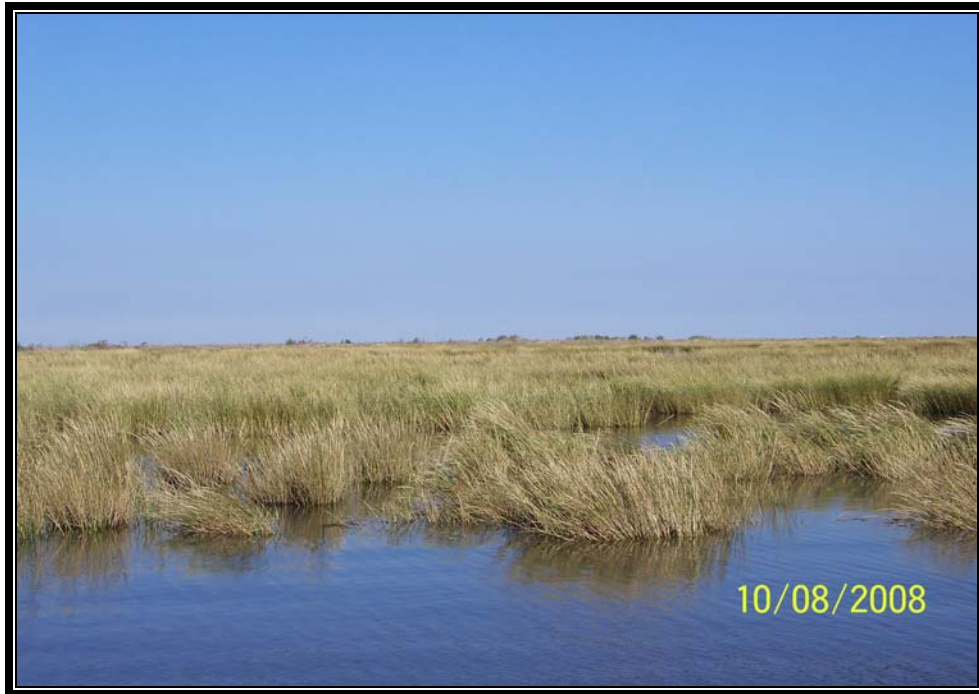
Photo 31 (0708) - Southwest corner of marsh creation area looking northwest. Marsh creation area is densely vegetated.

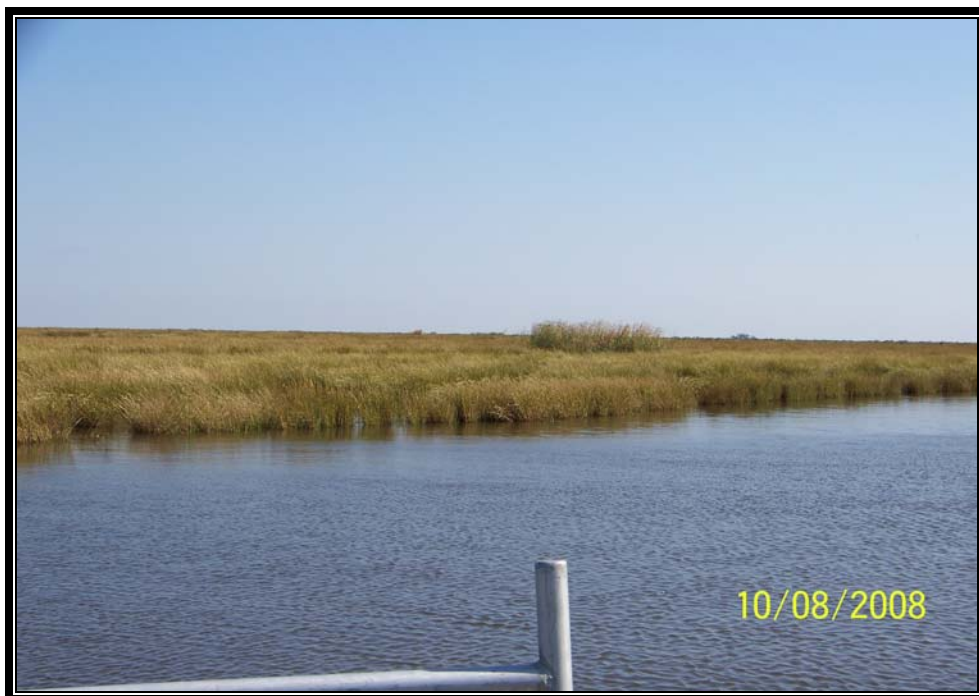
Photo 32 (0709) - Southwest corner of marsh creation area looking northeast. Marsh creation area is densely vegetated.

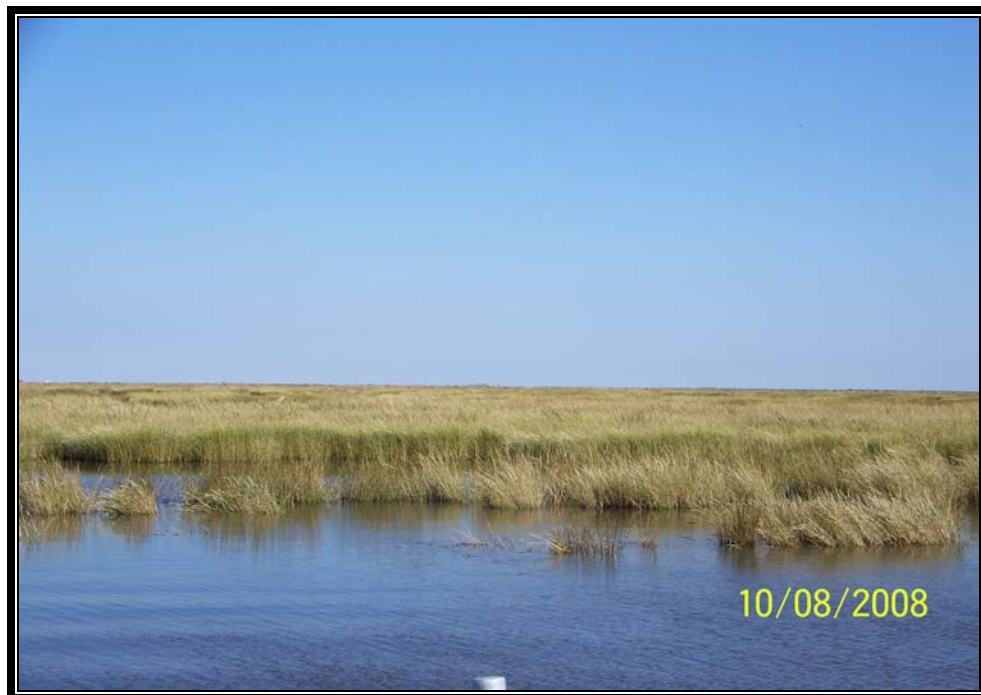
Photo 33 (0710) - Southwest corner of marsh creation area looking north. Marsh creation area is densely vegetated.

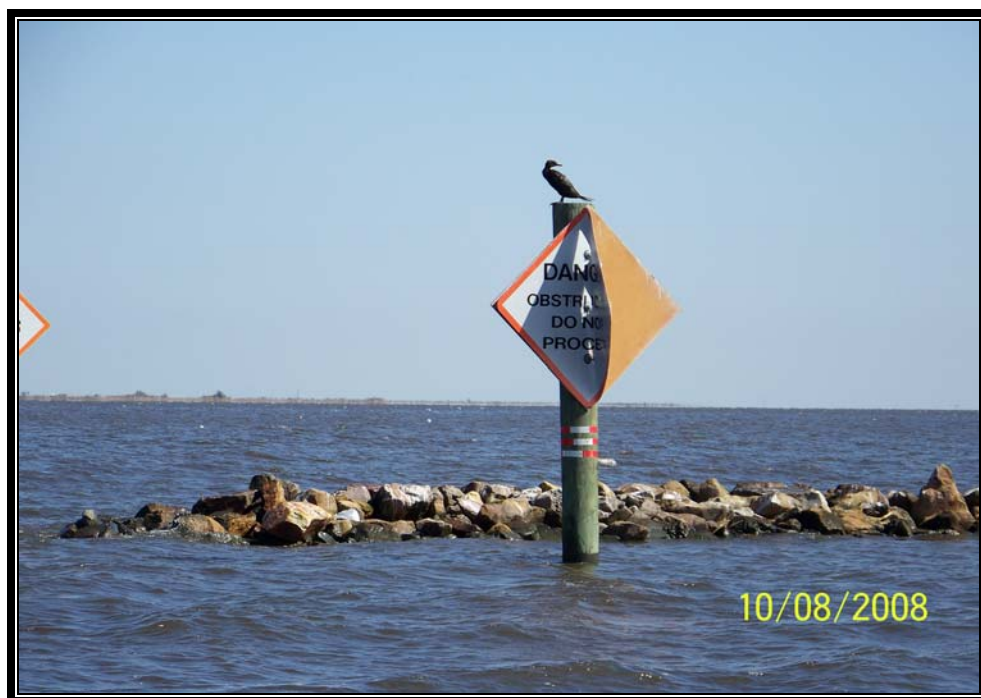
Photo 34 (0711) - Rock Segment 1. South-facing warning sign damaged by hurricanes.
